THE UNITED STATES
STRATEGIC BOMBING SURVEY

THE EFFECTS
OF
THE ATOMIC BOMB
ON
HIROSHIMA, JAPAN

Volume III

Physical Damage Division

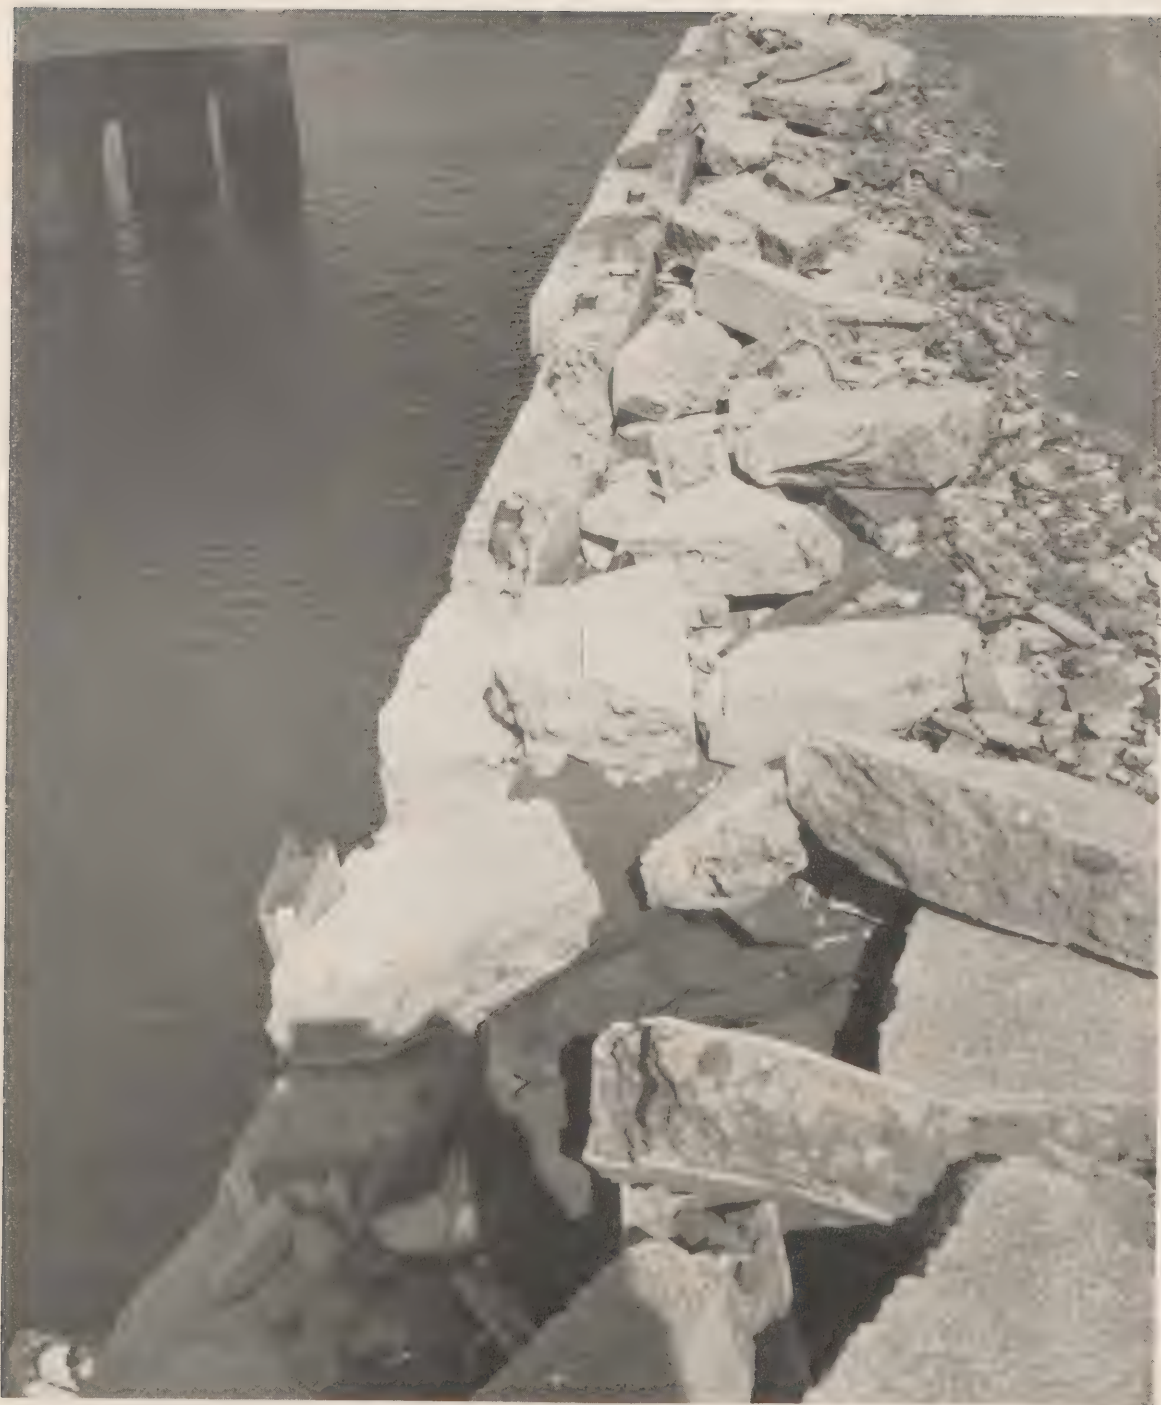
PHOTO 48-XII. Bridge 23. Cast-iron post sections and concrete railing sheared off east curb by blast (860 feet to GZ, 2,170 feet to AZ).

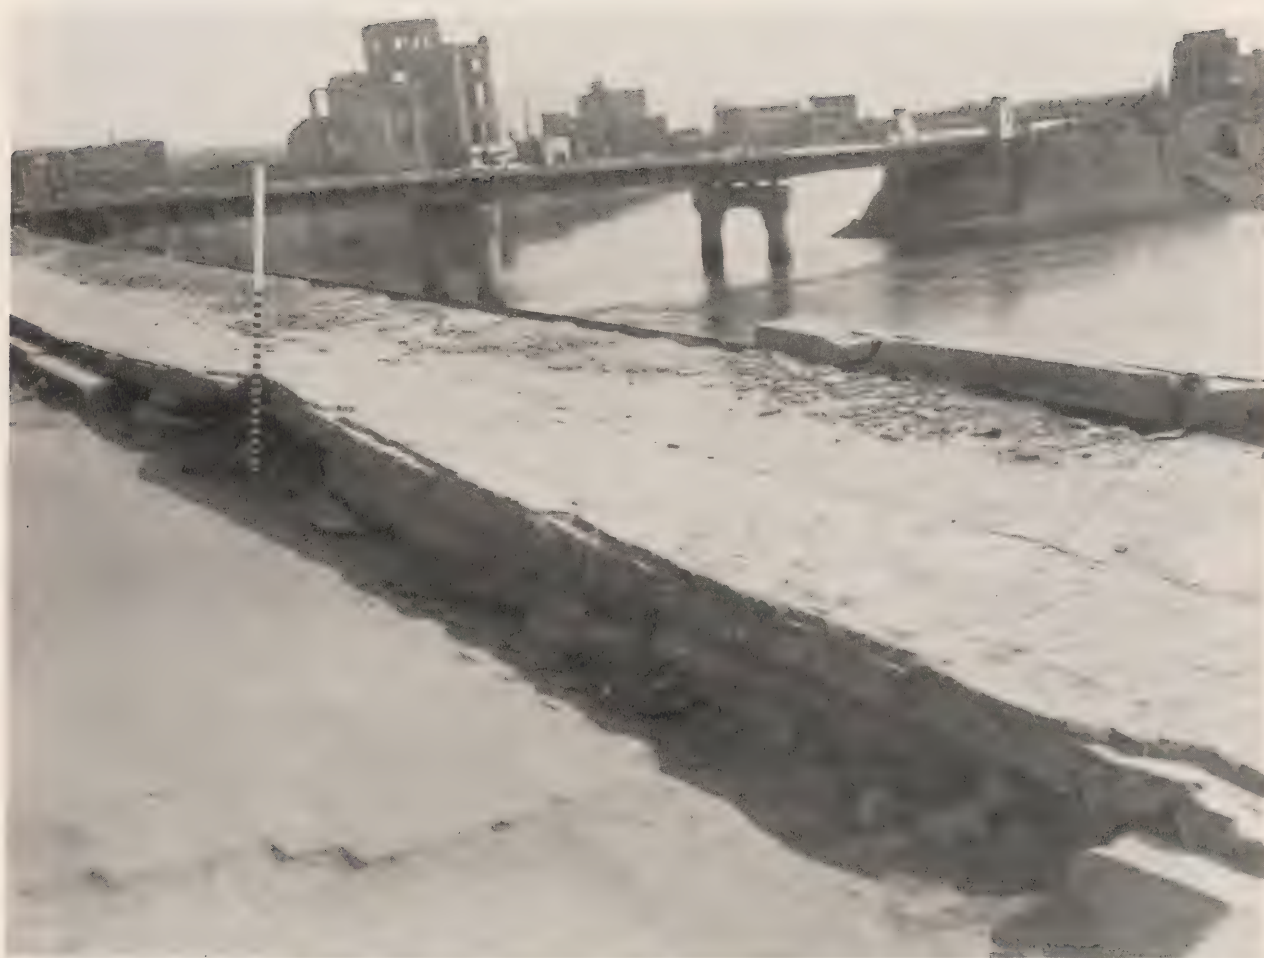
PHOTO 51-XII. Bridge 24. Southeast part of bridge over Ota-Gawa. Railing damaged by blast (1,000 feet to GZ, 2,230 feet to AZ).

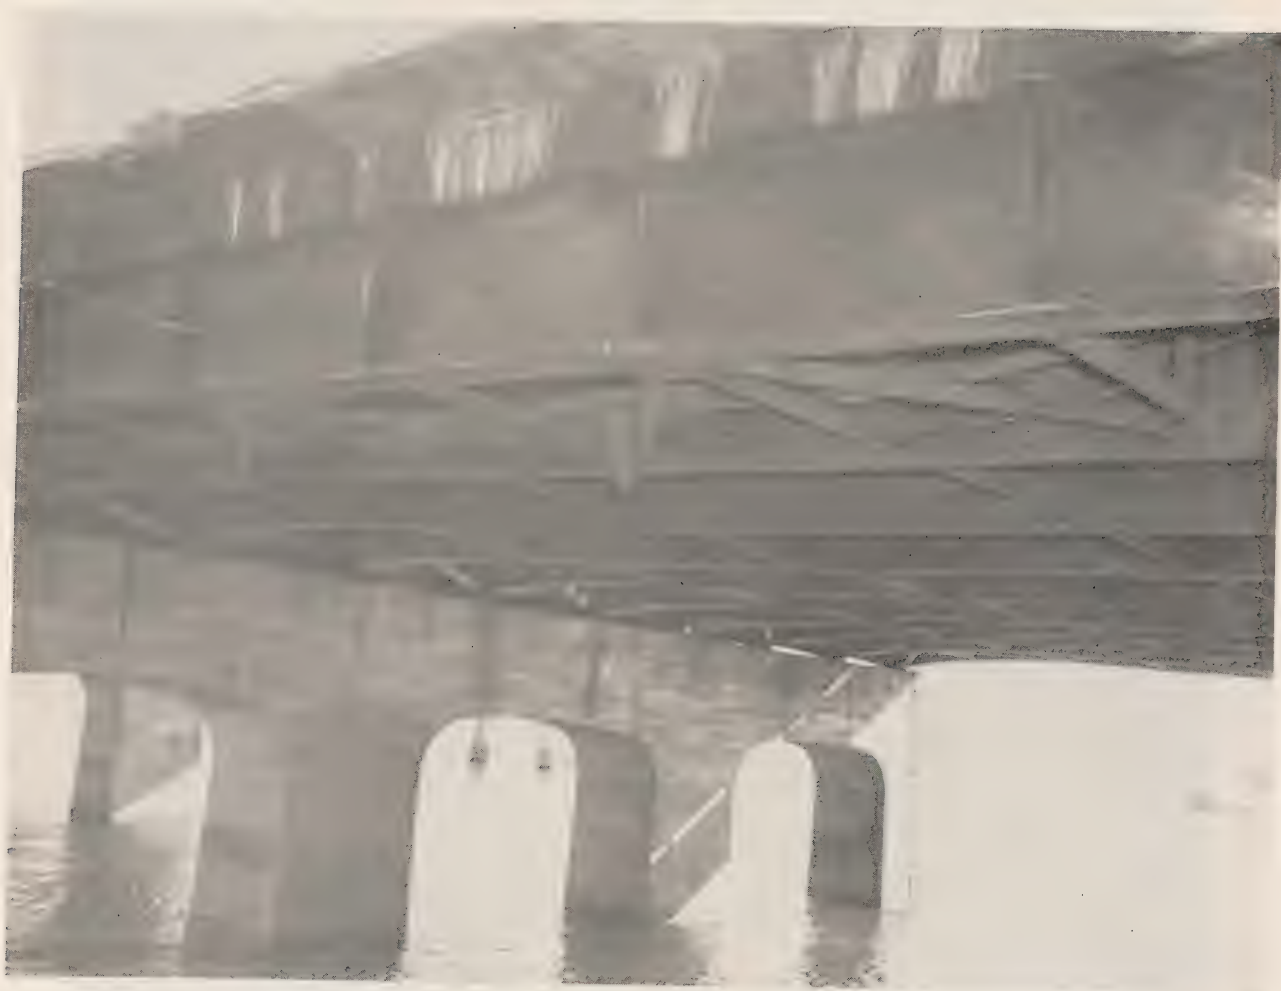
PHOTO 63-XII. Bridge 24. Underside of steel-plate girders and cross-members of west abutment. No structural damage (1,000 feet to GZ, 2,230 feet to AZ).

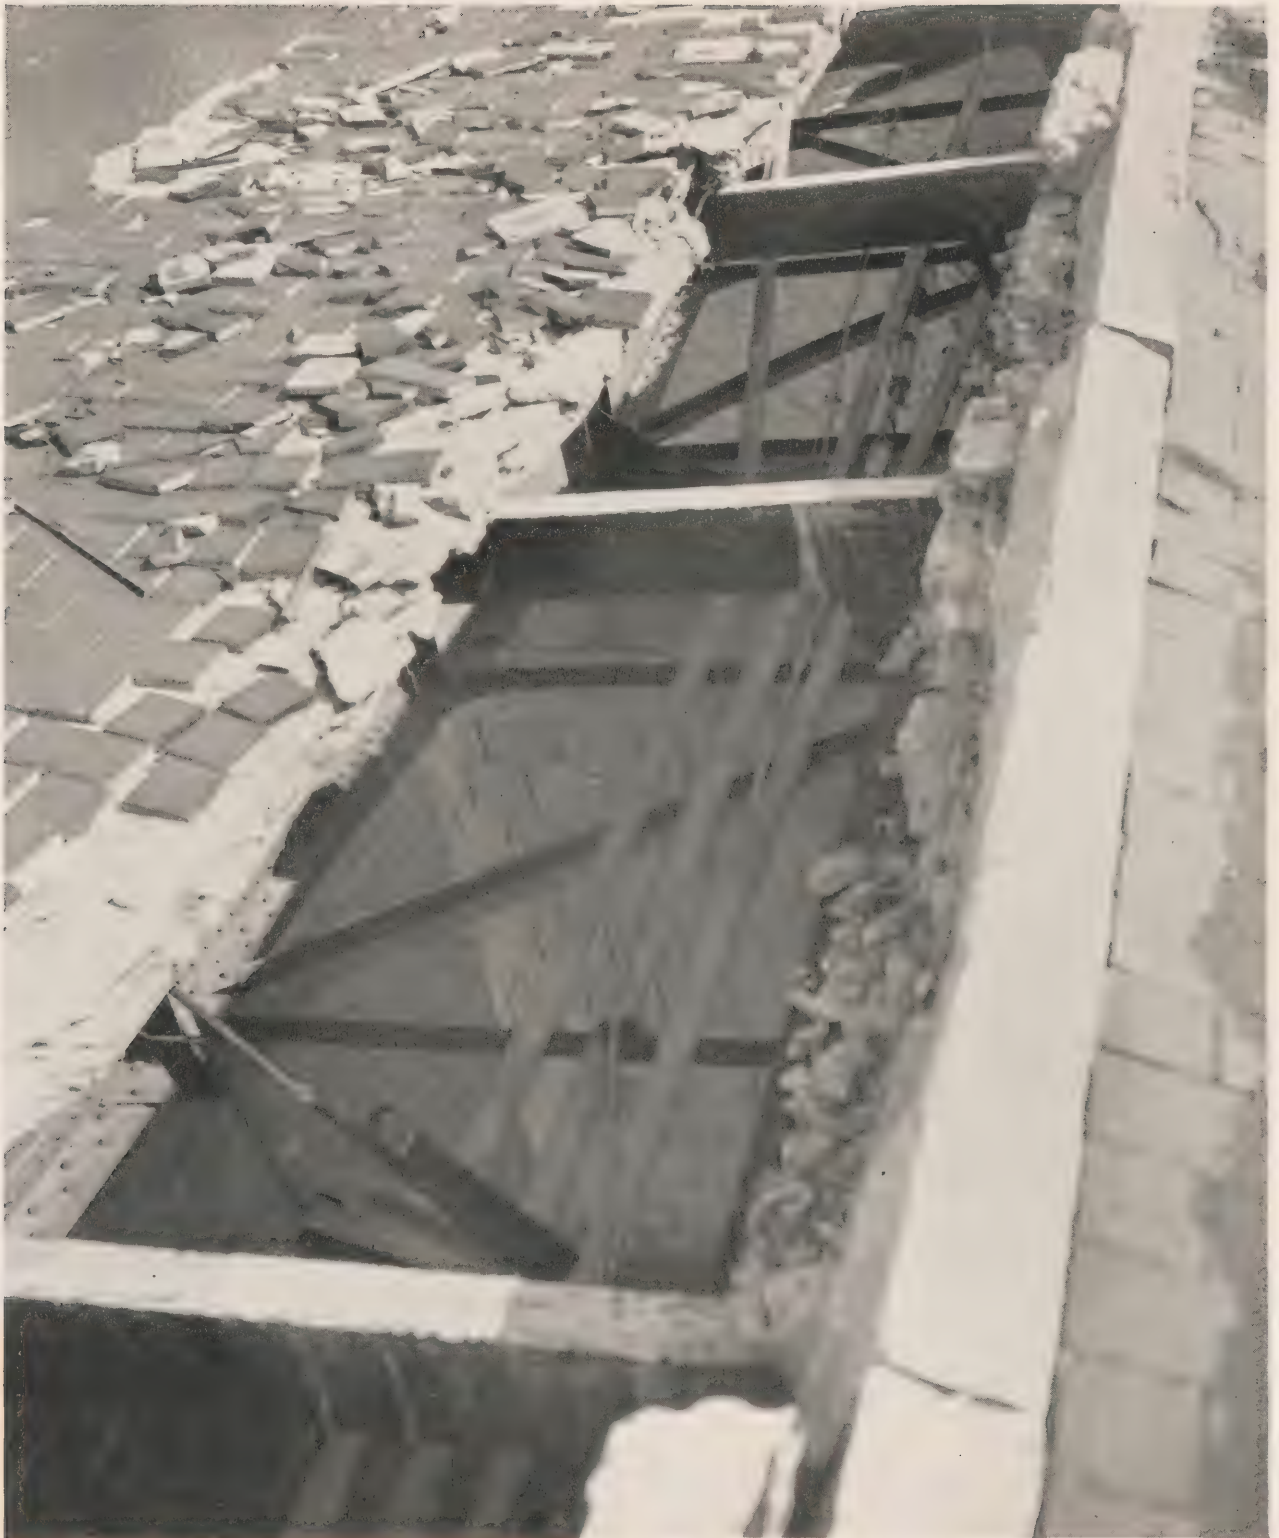
PHOTO 64-XII. Bridge 24. Underside of steel-plate girders and cross-members at west abutment. No structural damage.

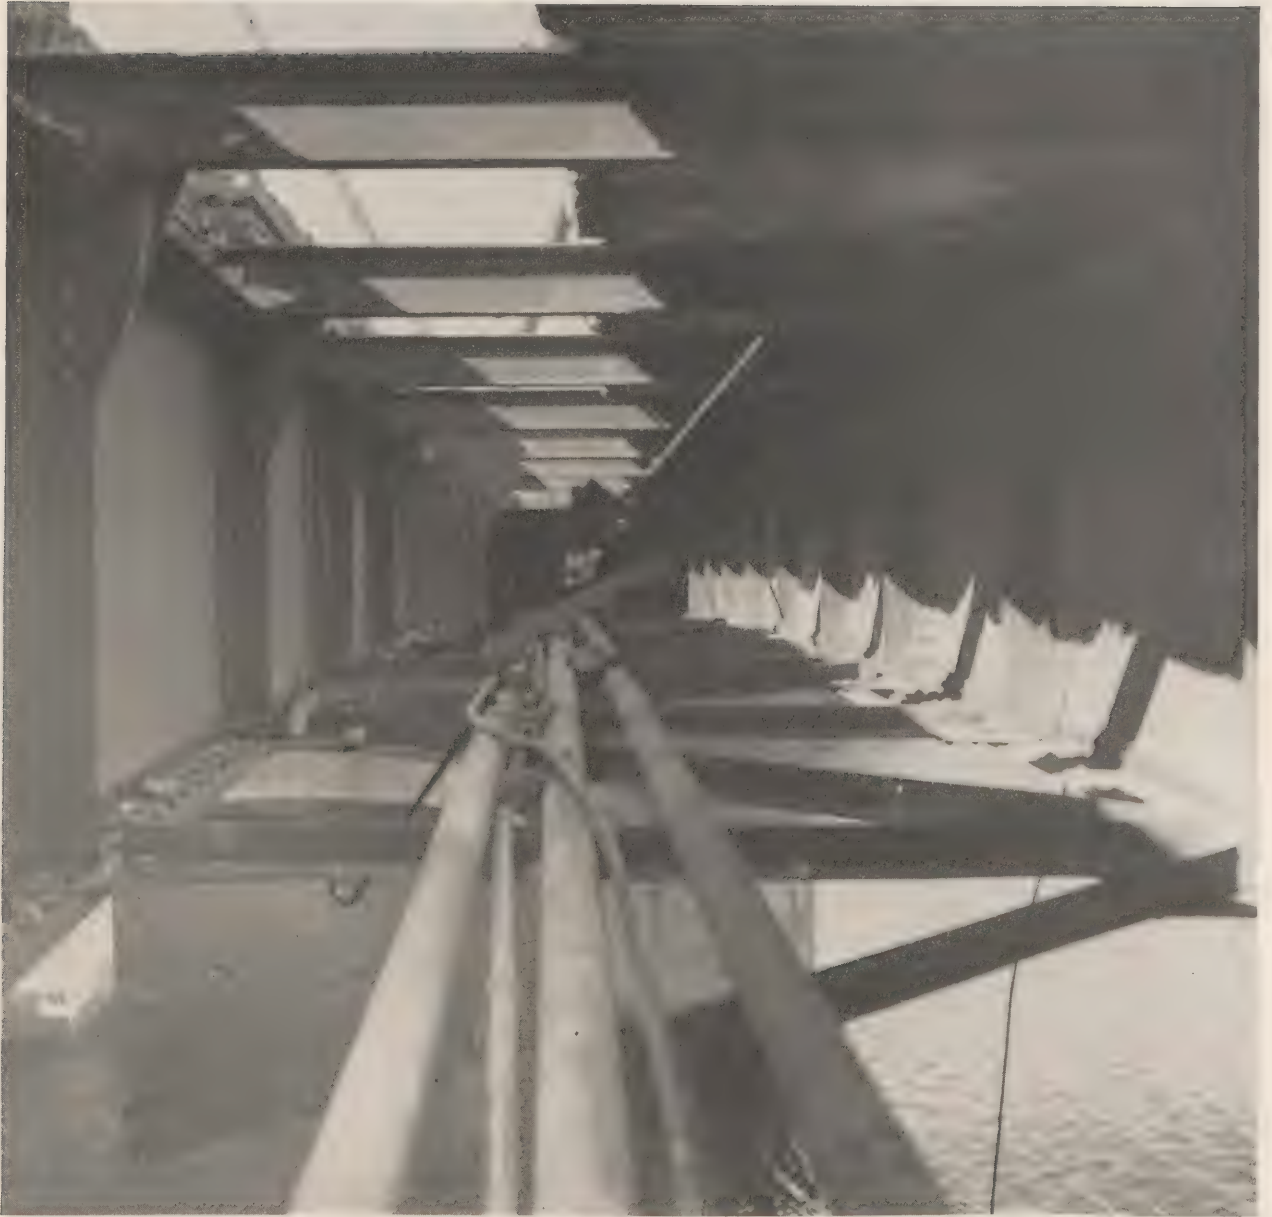
PHOTO 65 XII. Bridge 24. Secondary framing of exterior girder under north walk at approximate bridge center.
No structural damage.

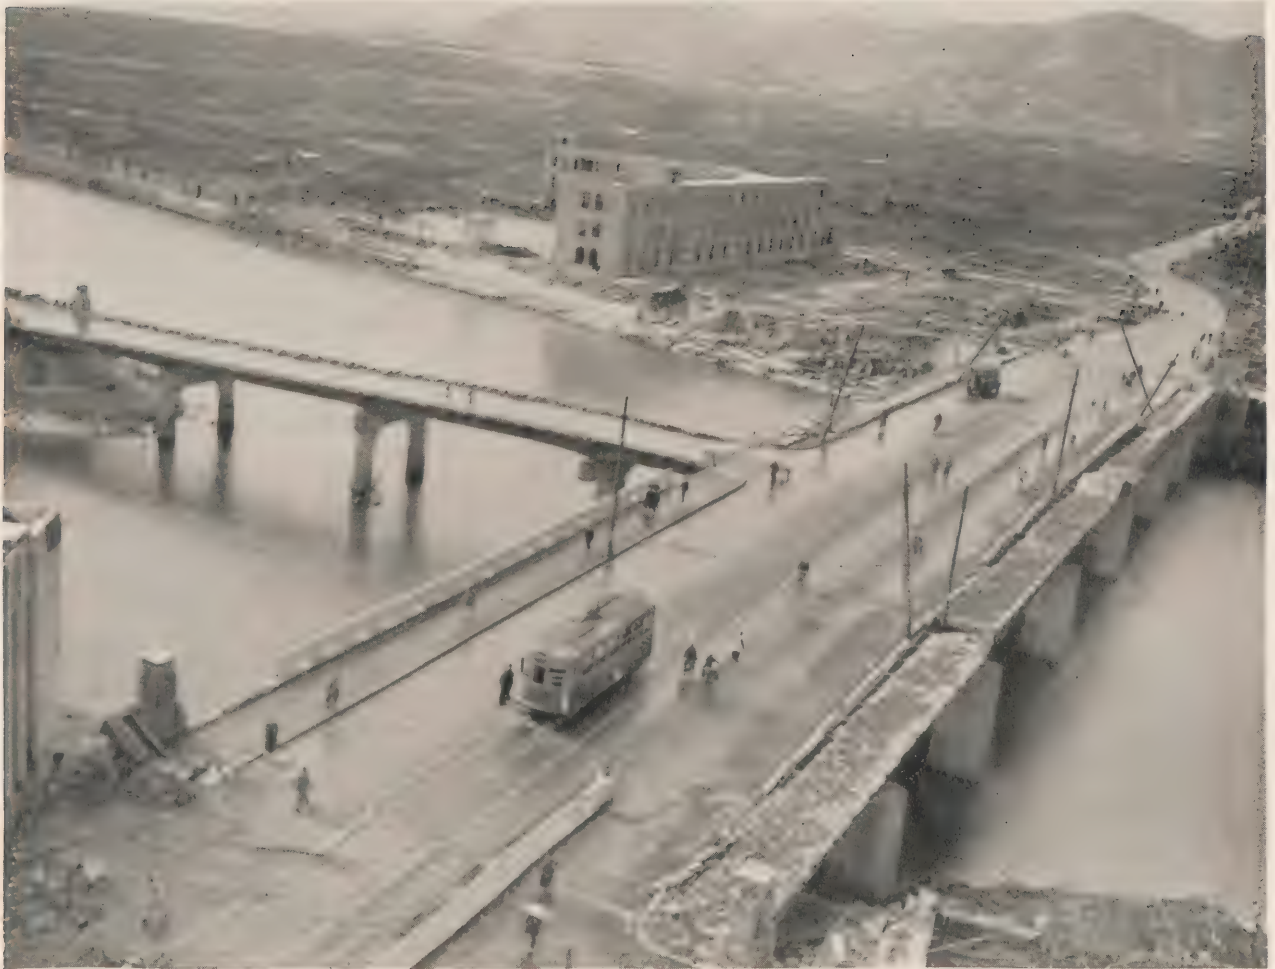
PHOTO 69-XII. Bridge 24. West end of bridge. Streetcar rails moved laterally 15 inches to the north when blast effects shifted bridge deck (1,000 feet to GZ, 2,230 feet to AZ).

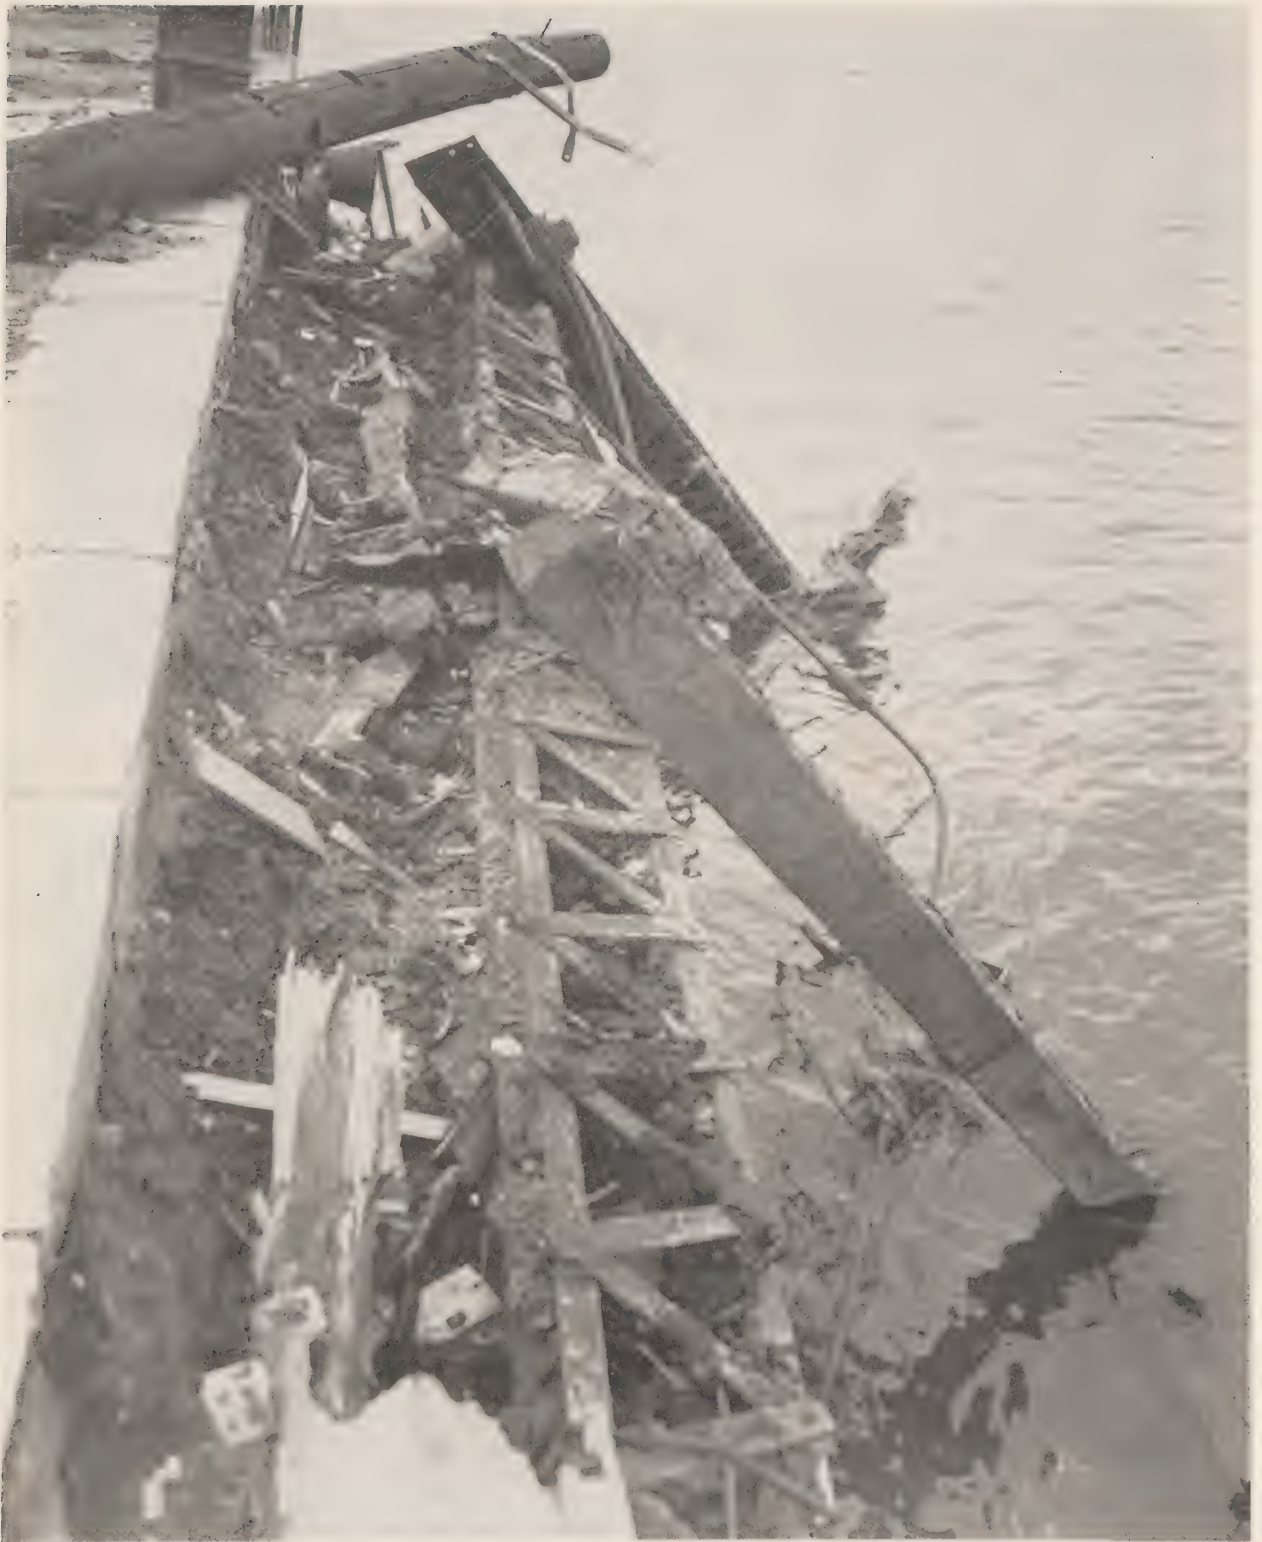
PHOTO 79-XII. Bridge 29. East abutment. Bridge totally damaged by blast (1,190 feet to GZ, 2,310 feet to AZ).

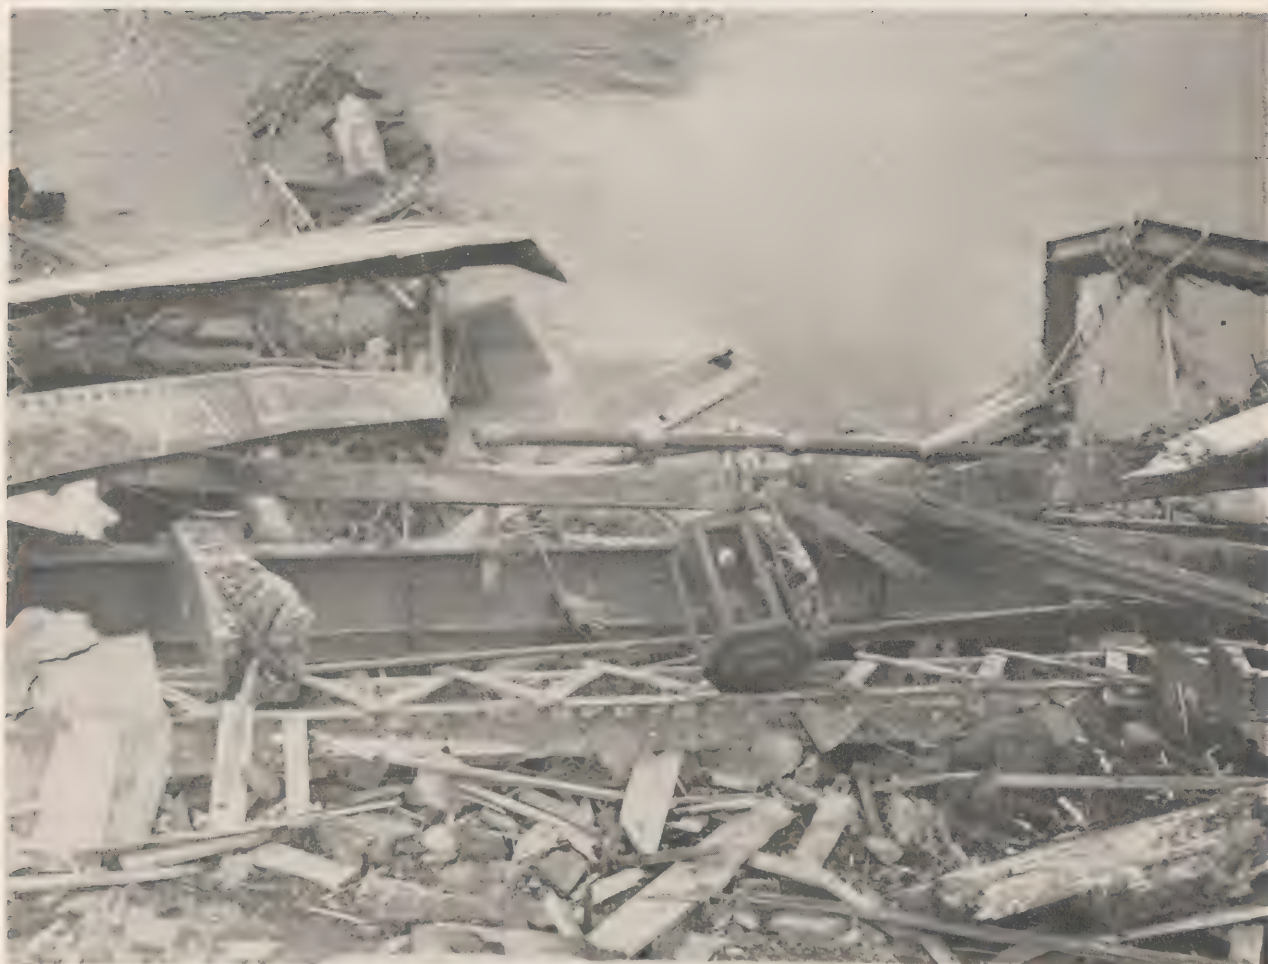
PHOTO 80-XII. Bridge 29. Looking east at debris at west abutment (1,190 feet to GZ, 2,310 feet to AZ).

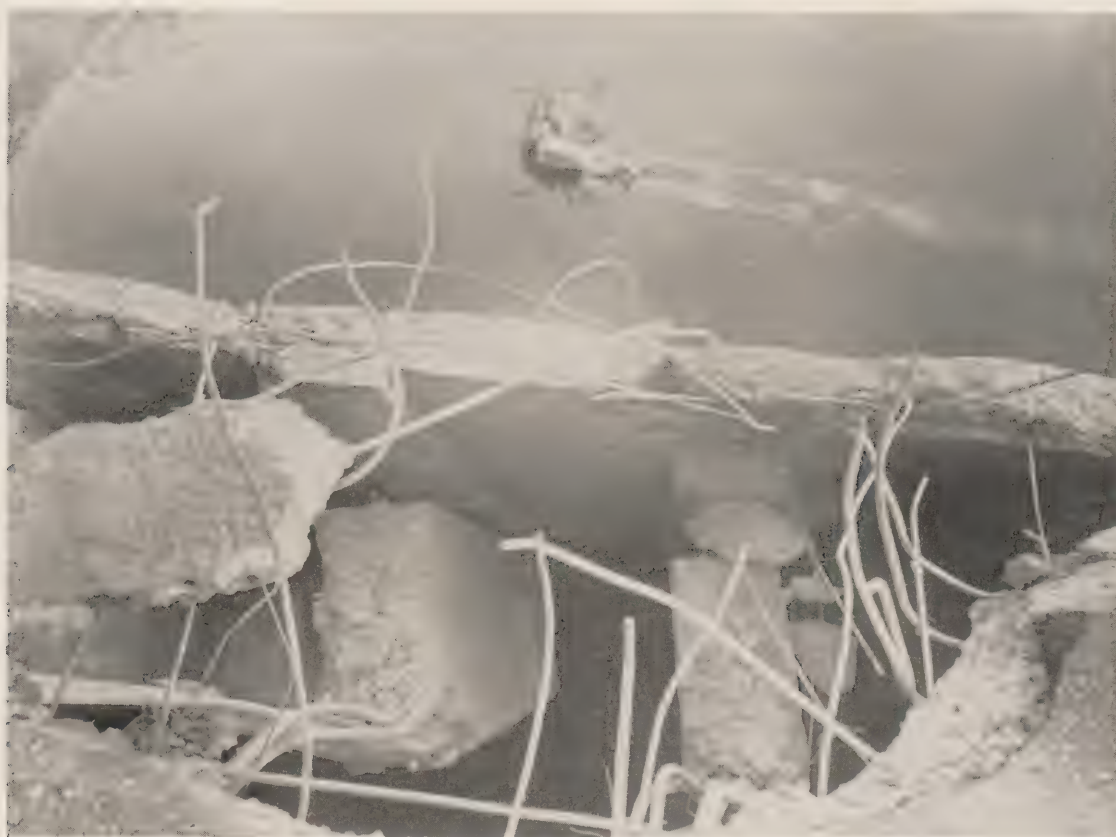
PHOTO 82-XII. Bridge 30. Fractured roadway deck and longitudinal beams. Note reinforcing steel and construction joint at junction of beams and slab.

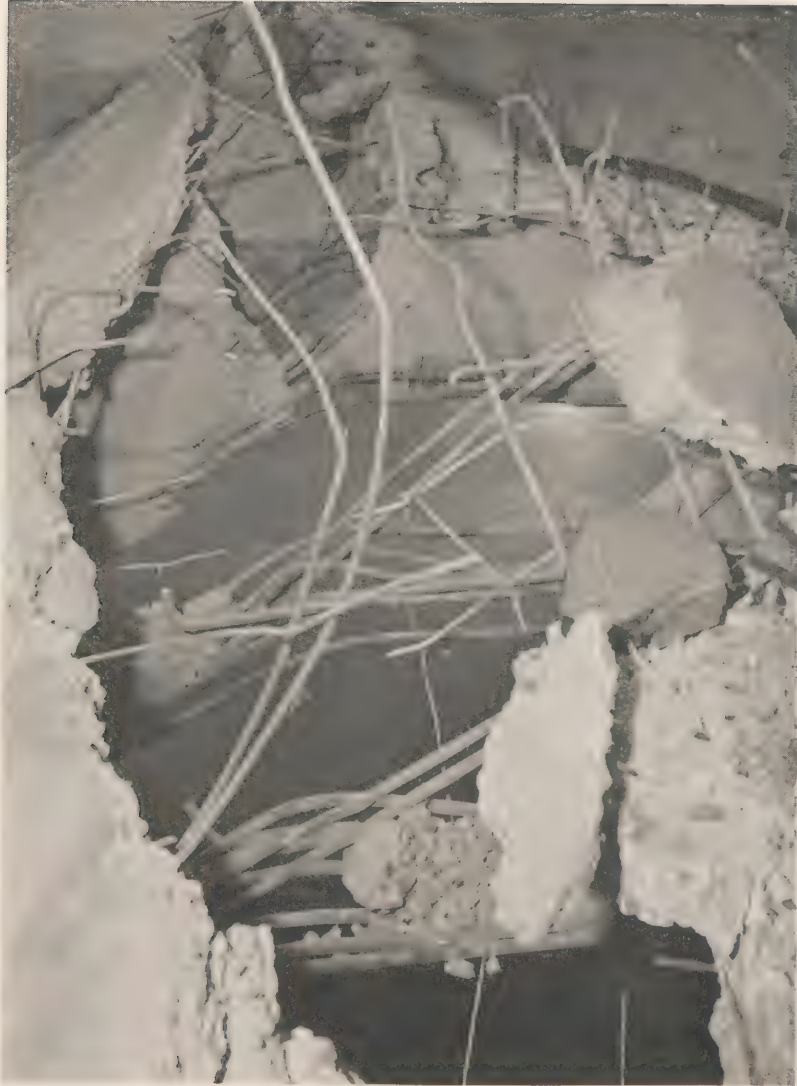
PHOTO 83-XII. Bridge 30. Steel reinforcement in fractured concrete girder.

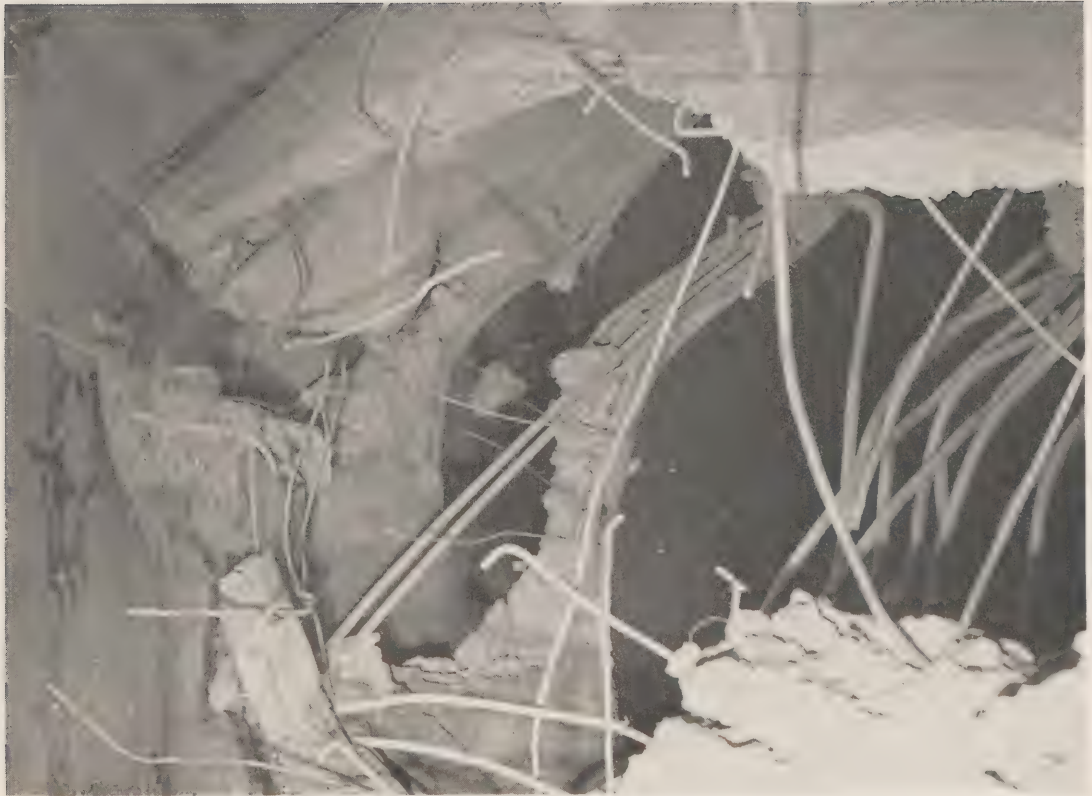
PHOTO 84-XII. Bridge 30. Fractured roadway deck and girder. Note reinforcing steel.

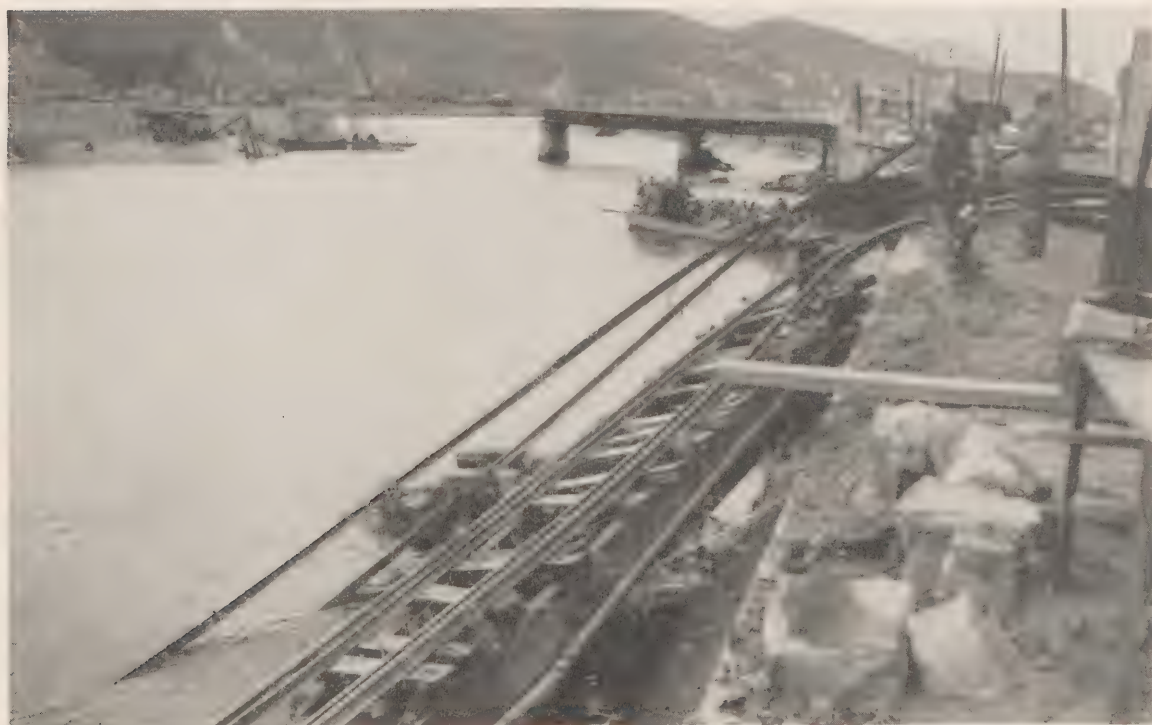
PHOTO 92-XII. Bridge 35. West abutment of trolley bridge. Totally damaged by flood (3,190 feet to GZ, 3,750 feet to AZ).

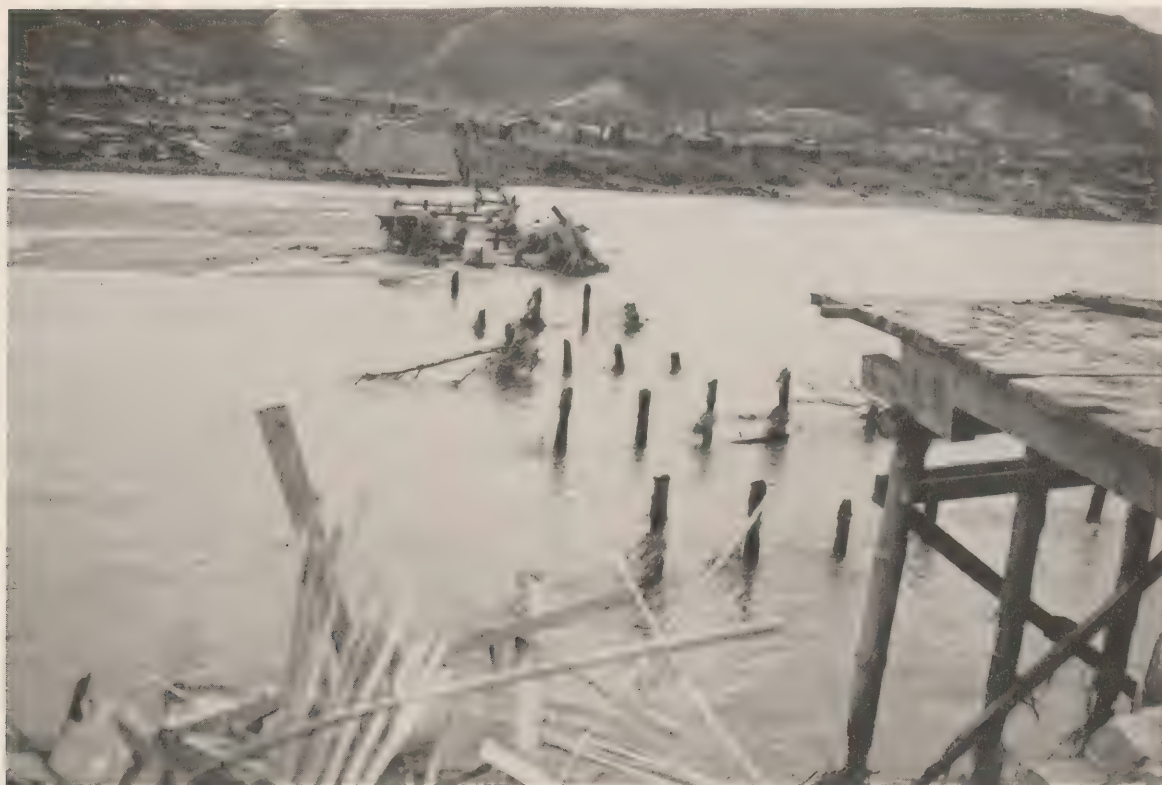
PHOTO 96-XII. Bridge 39. Looking northwest at remains of timber bridge over the Temma-Gawa. Severely damaged by fire (easterly $\frac{1}{3}$) and later totally damaged by flood (3,880 feet to GZ, 4,390 feet to AZ).

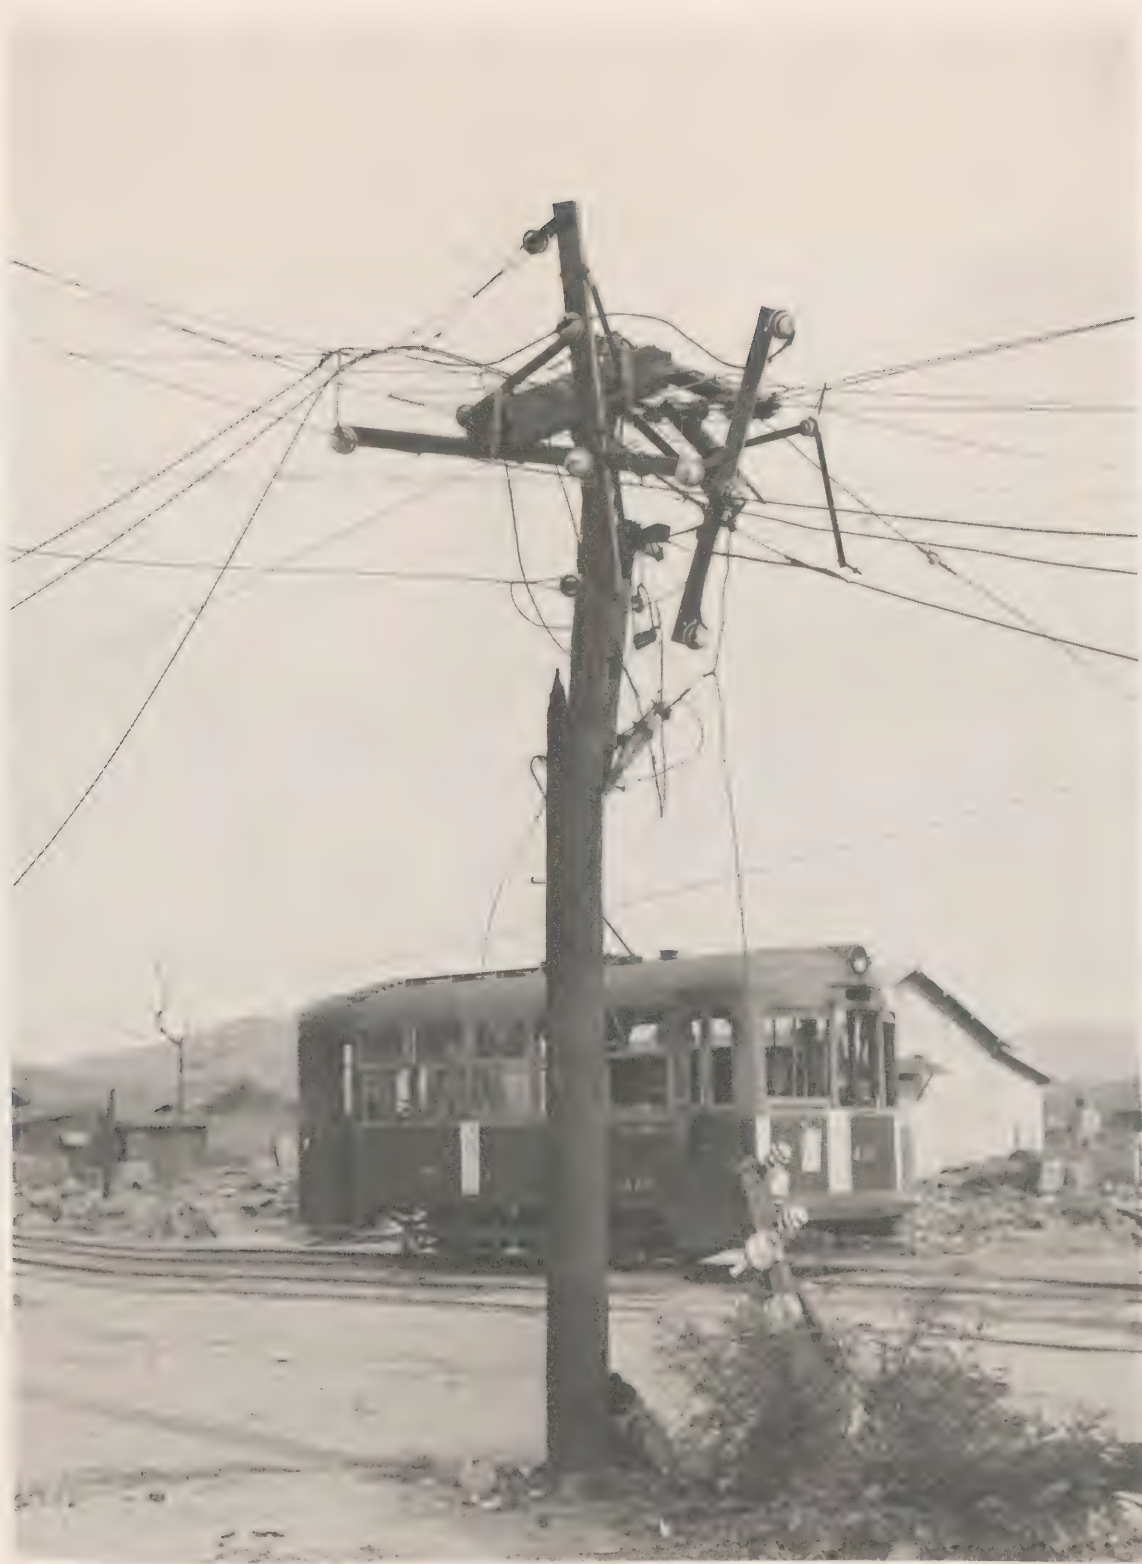
PHOTO 13-XIII. Blast damage to pole and car 4,000 feet southwest from GZ.

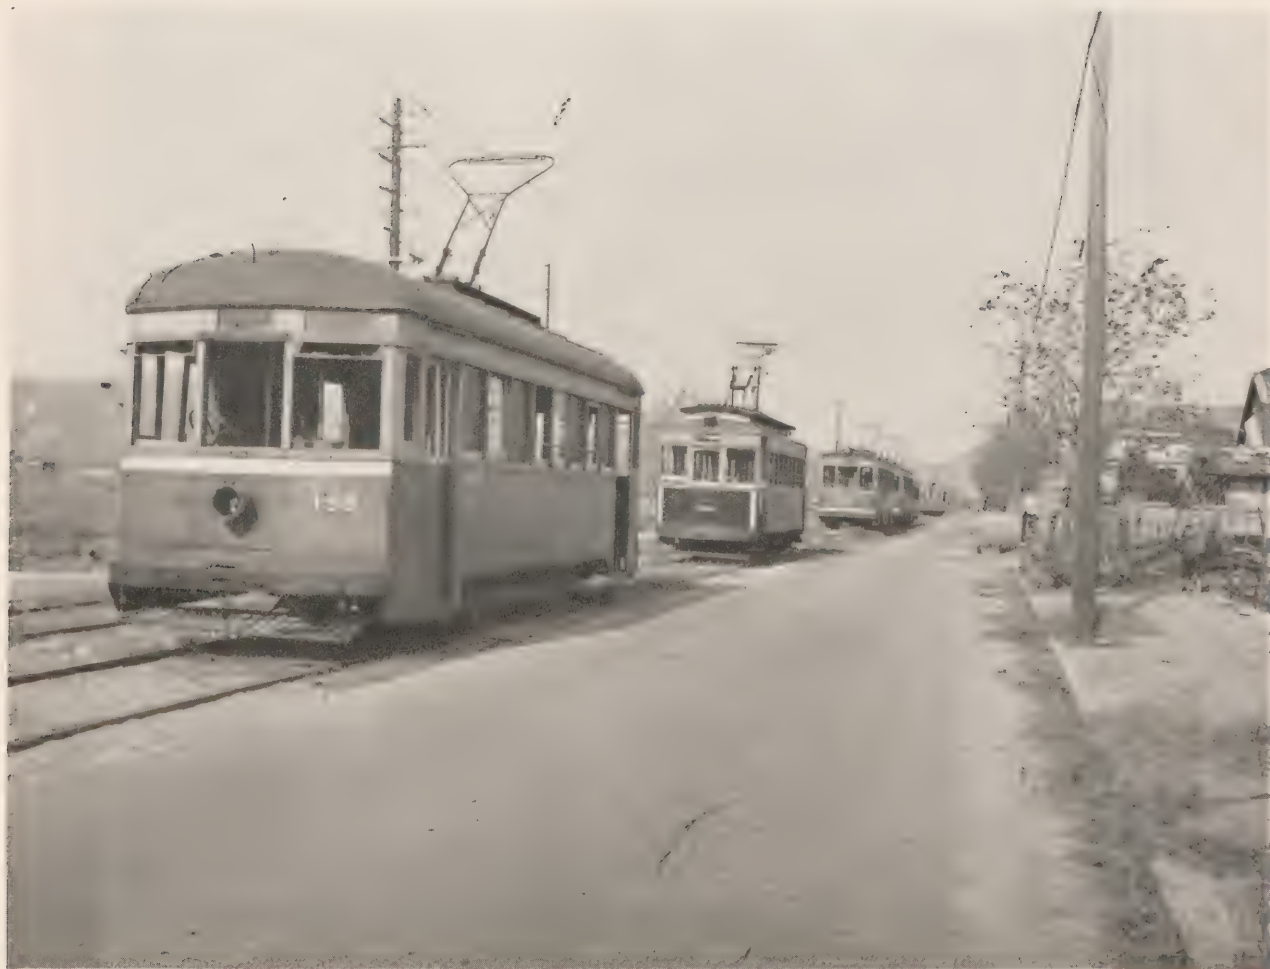
PHOTO 14-NIII. Blast damage to cars 9,000 feet southwest of GZ. Because of the extent of damage to the overhead transmission system in the Eba area (Fig. 1) no effort was made to put this section of streetcar line in service and consequently return the cars in the above photograph to Sendamachi for repairs.

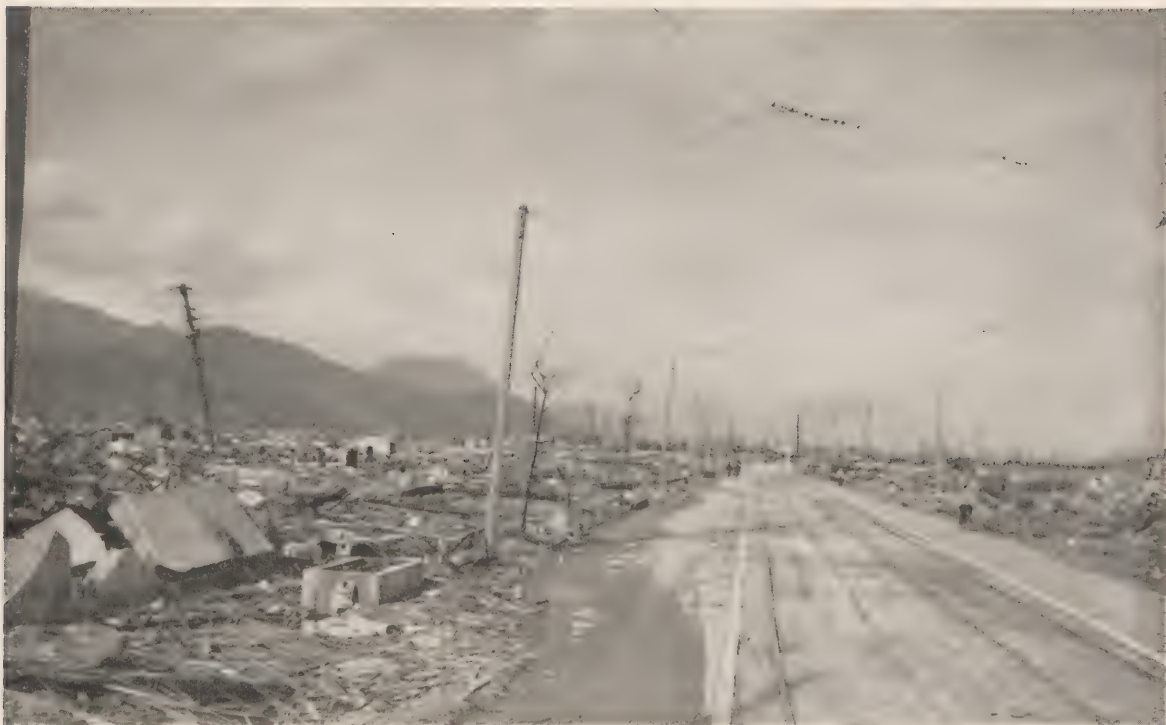
PHOTO 19-XIII. Blast damage to wood and steel poles 2,500 feet northwest of GZ.

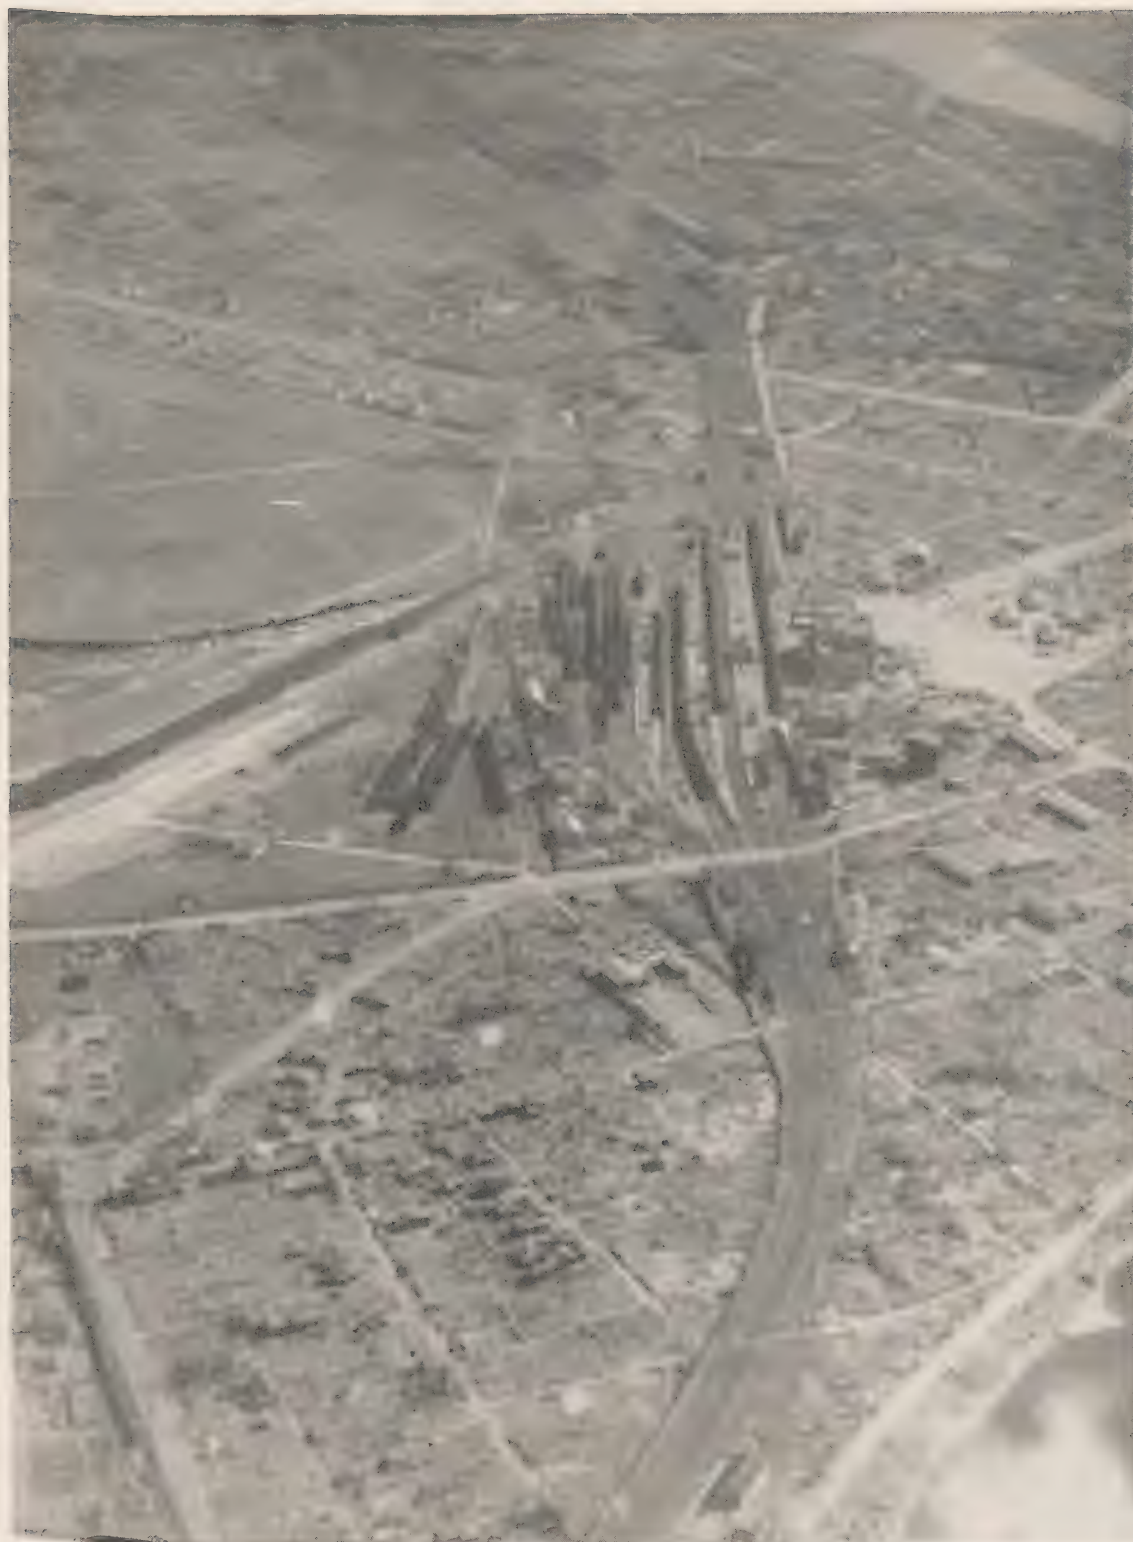
PHOTO 35-XIII. General view of passenger station area showing bomb damage, 6,300 feet from GZ.
